Failure Analysis Report of Road Runner Power MOSFET

Prepared for:
Acme Supplies, Inc.

Report Date
IAL Project 15555

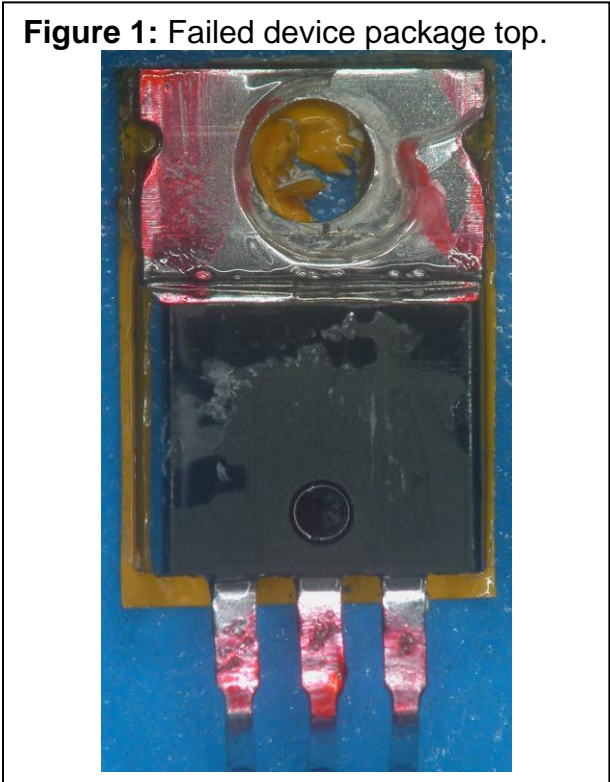
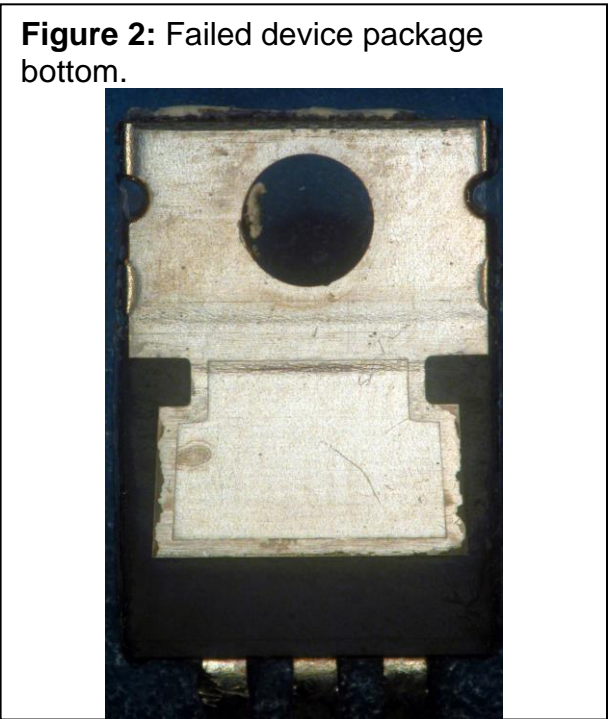
The external visual inspection of the failed device revealed no defects (references figures 1 through 3).

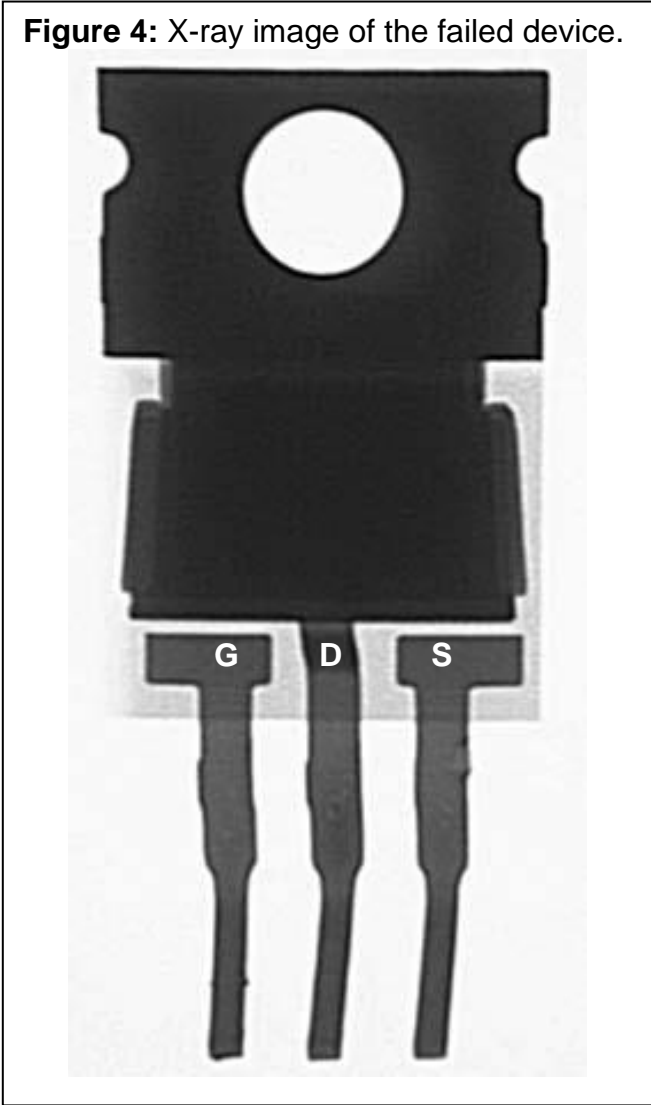
An inspection of the failed device using a real time x-ray system (reference figures 4 through 6). Figures 5 and 6 show the die is on or very close to the mold lock channel. Figure 5 shows die attach has flowed into the mold lock channel (dark line on the along upper die edge).

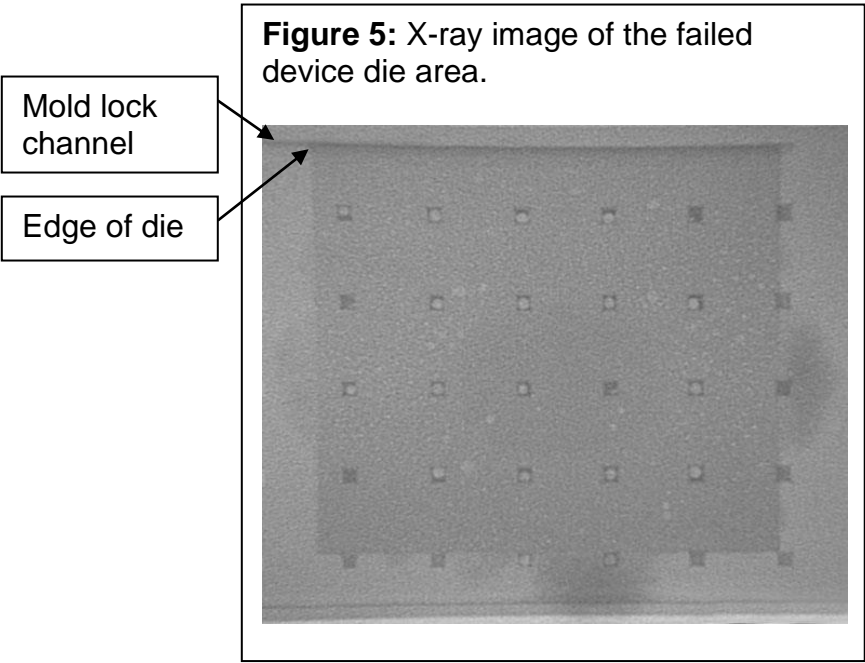
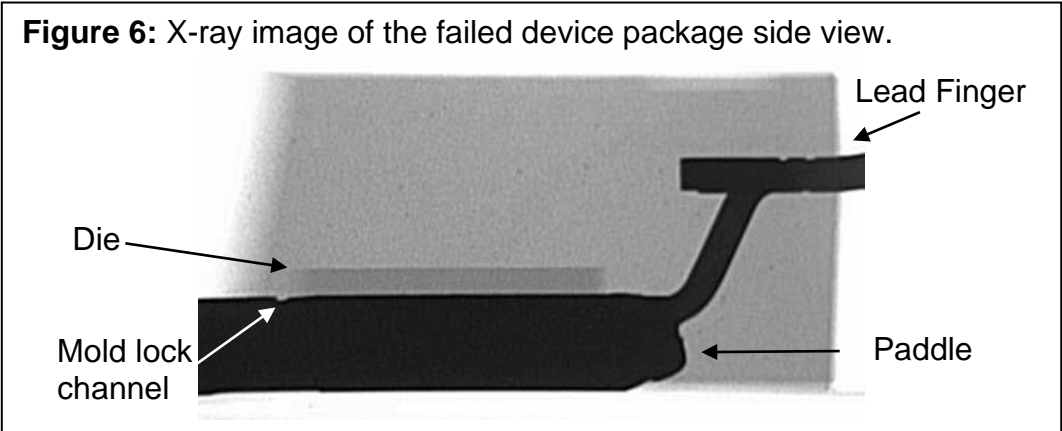
Mechanical stress is the most likely cause of this failure. Placing the die very close or over the mold lock, and having die attach in the mold lock would reduce the plastic mold compound adhesion to the paddle. The delamination from this would cause stress on the die. This delamination and stress build-up could occur over time ultimately resulting in a crack. Based on the visual inspection and the SAM results, the crack most likely started on the left edge of the die. Once the crack occurred, a leakage site formed along the crack edge causing the damaged polysilicon gate. This electrical defect was the symptom detected as failure.

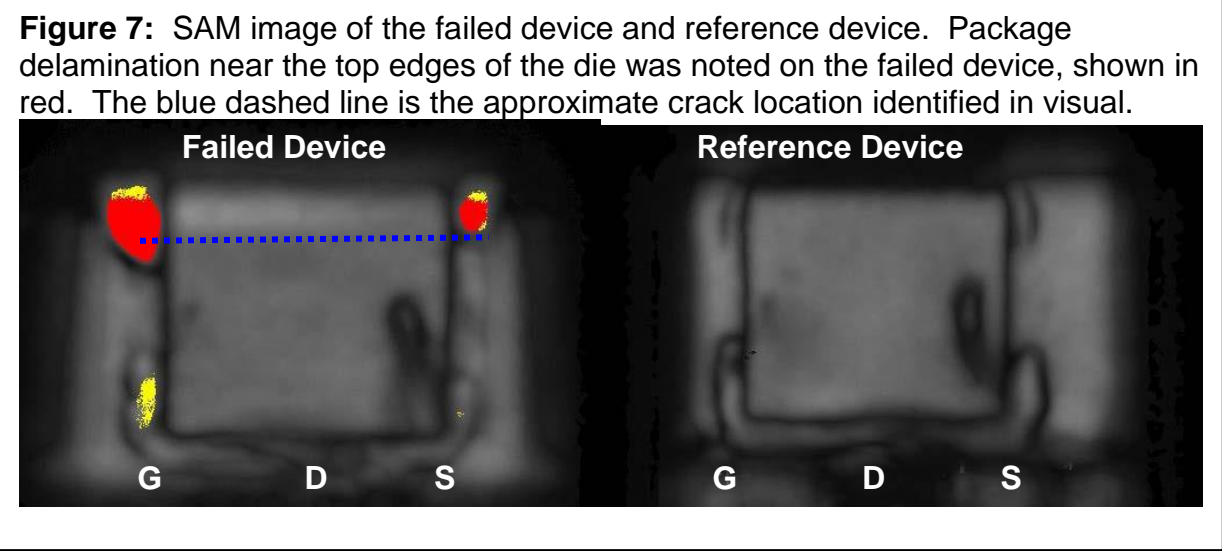
After the conformal coating was removed, Scanning Acoustic Microscopy (SAM) was performed on the failed devices. Package delamination was noted on the failed device only (reference figure 7). SAM analysis also shows a lighter colored area on the upper part of the die. This was later found to be the area of the die that was cracked.

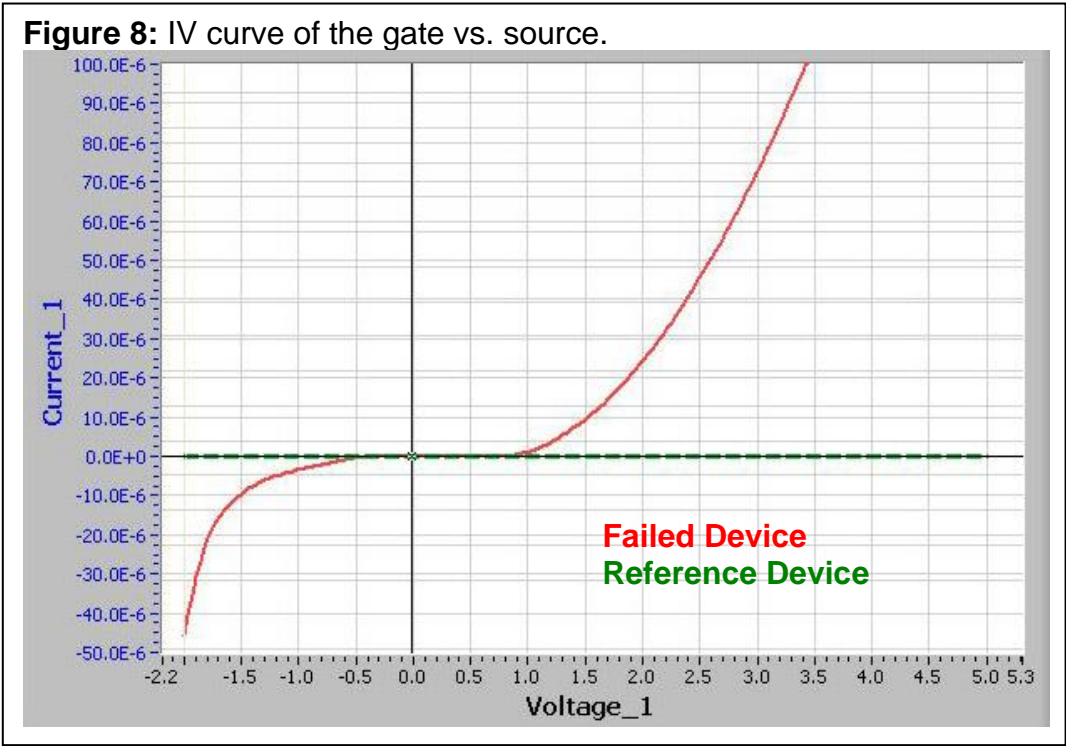
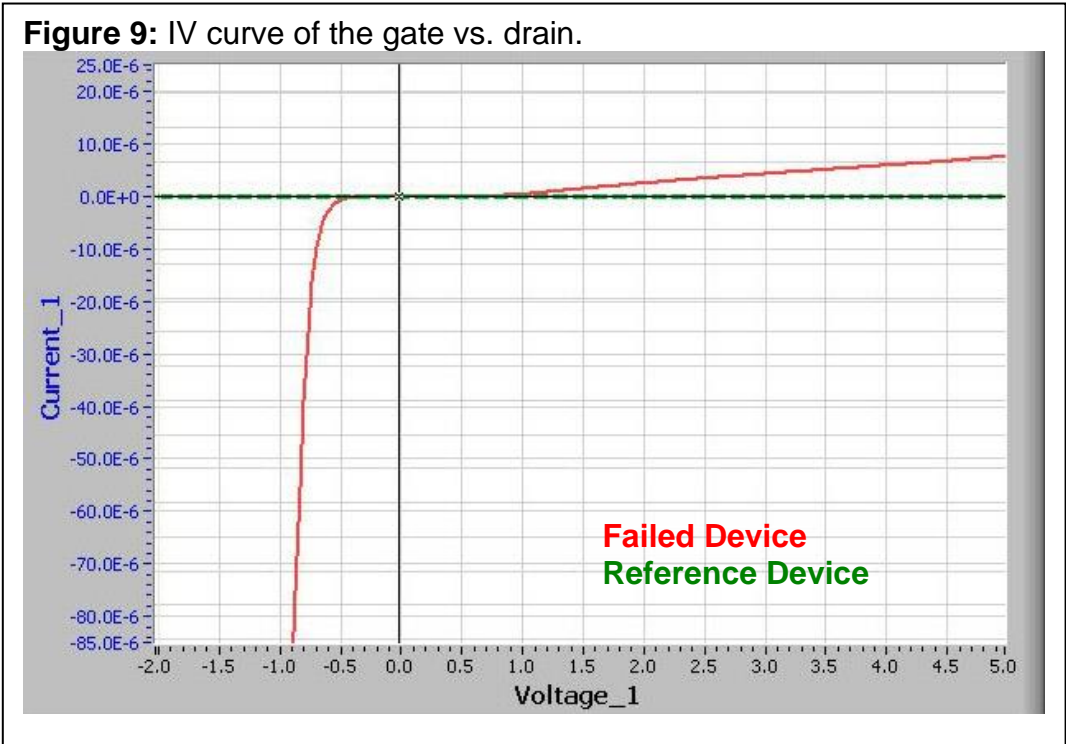
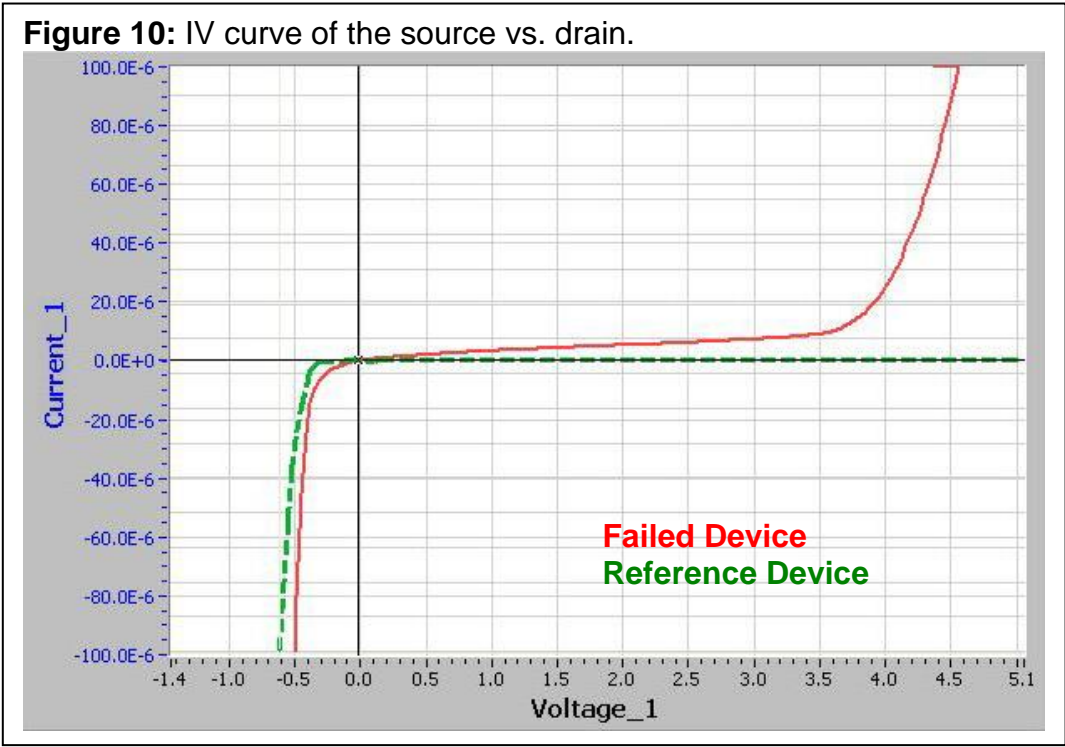
Electrical testing showed that all leads had early breakdowns. The gate to source characteristics showed the largest current leakage (70uA at 3v). After decapsulation, a cracked die was observed. Liquid Crystal analysis identified a transition site along the die crack near the source pad. Other than the die crack, no additional surface damage was observed at the liquid crystal site. Deprocessing the device showed a damaged gate area at the liquid crystal site.

Curve trace analysis was performed. Electrical anomalies were noted on all leads (reference figures 8 through 10).

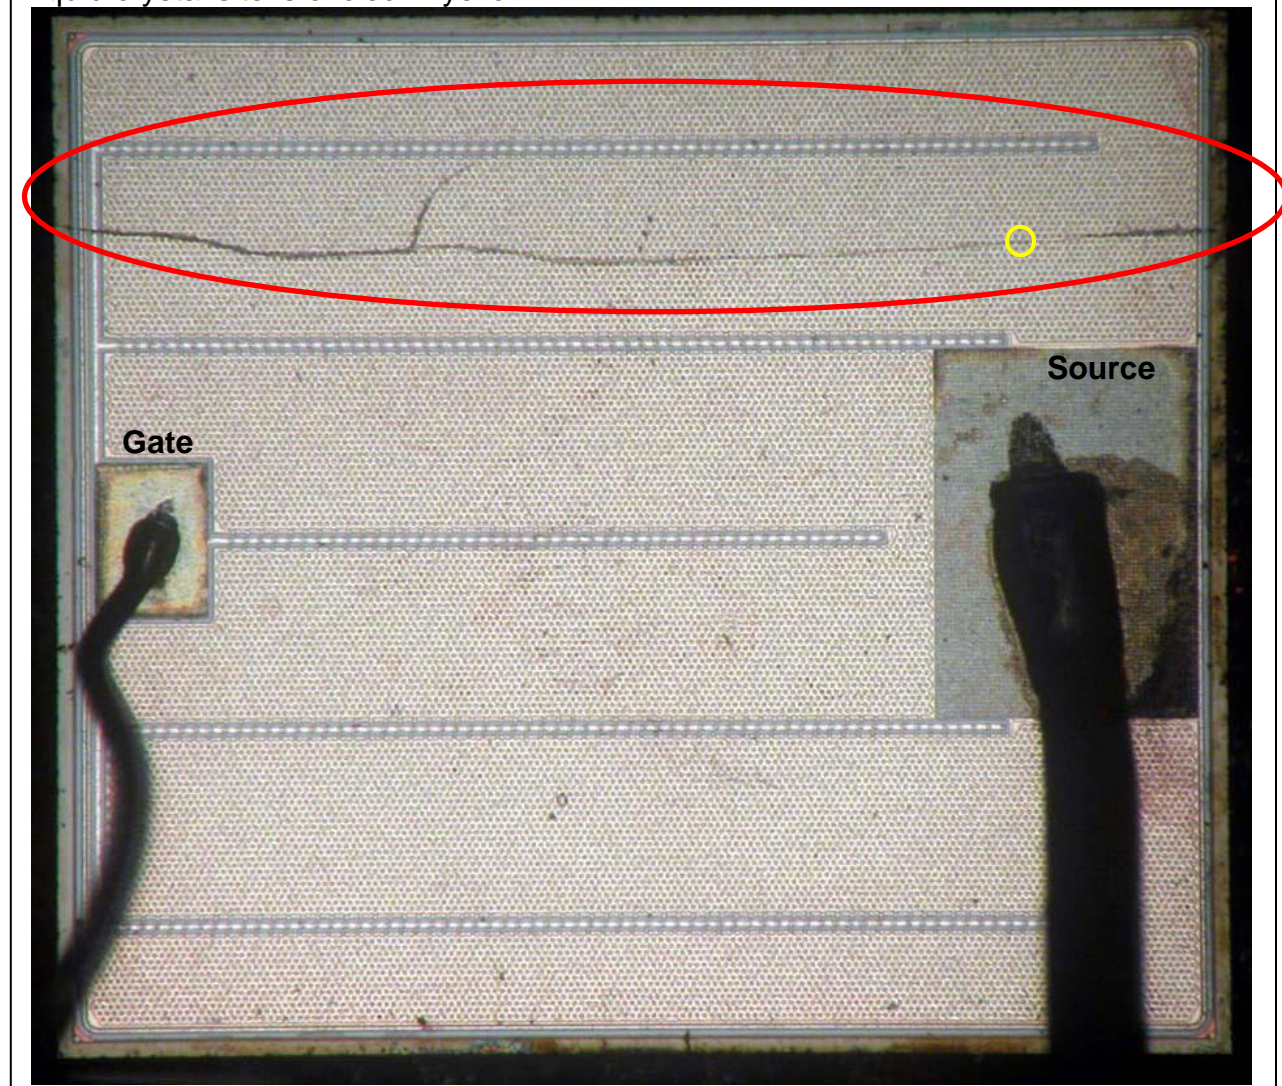
Vibration, flexing, rapid thermal changes, or excess mounting screw torque would add to the predisposition of expanding the crack. Once the die was cracked, metal shorting (along the crack) most likely caused the gate damage seen at the liquid crystal transition site.

The plastic encapsulant was chemically removed in order to inspect the die. A crack was seen across the die surface (reference figures 11 and 12). Liquid Crystal analysis was performed by biasing the gate to source. A transition site was observed along the crack near the source pad. With the exception of the crack, no other damage was noted at the liquid crystal site.

Figure 11: Photograph of the failed device die; the noted crack is circled in red. The liquid crystal site is circled in yellow.

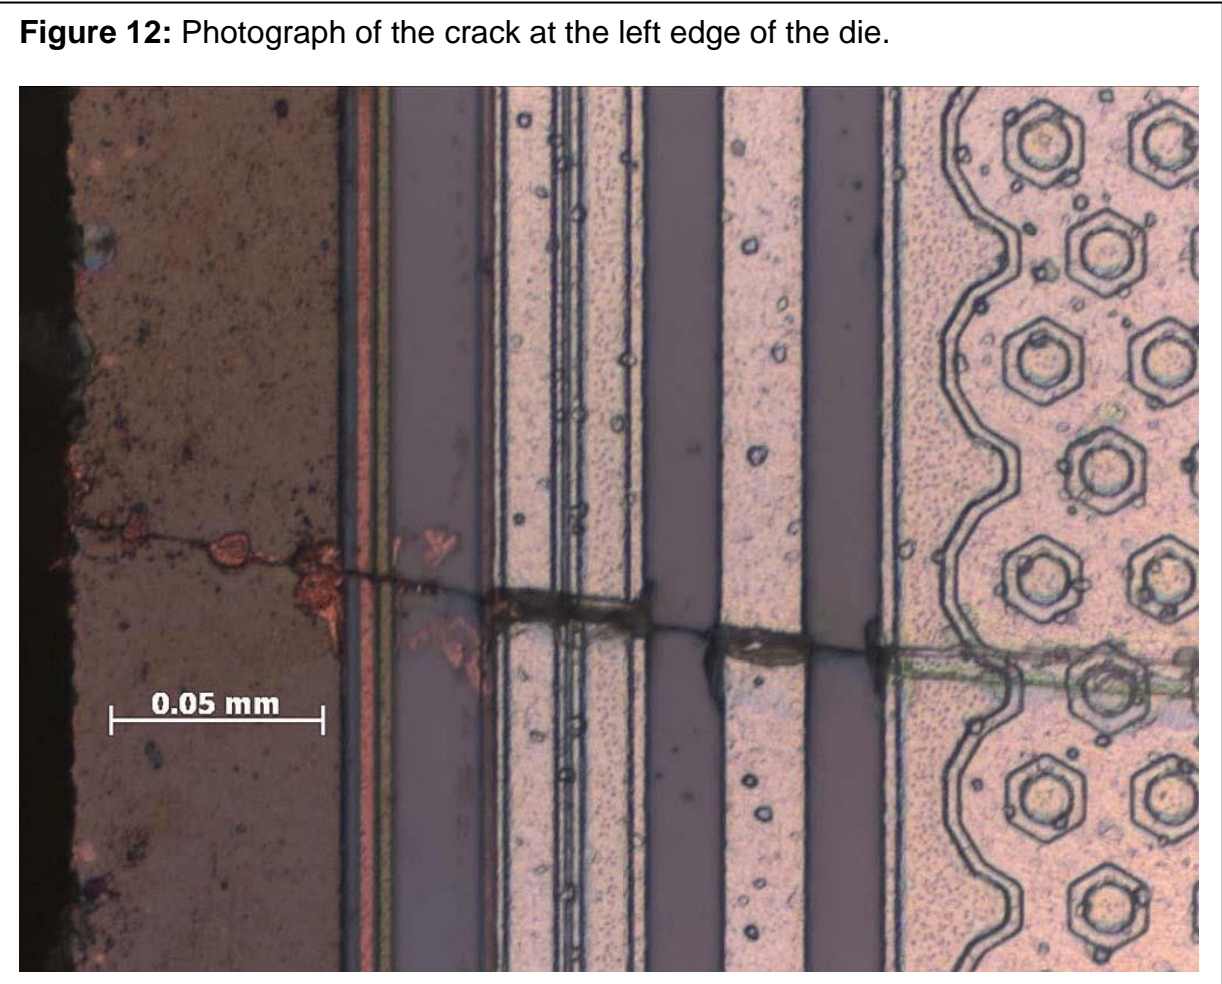
Figure 12: Photograph of the crack at the left edge of the die.

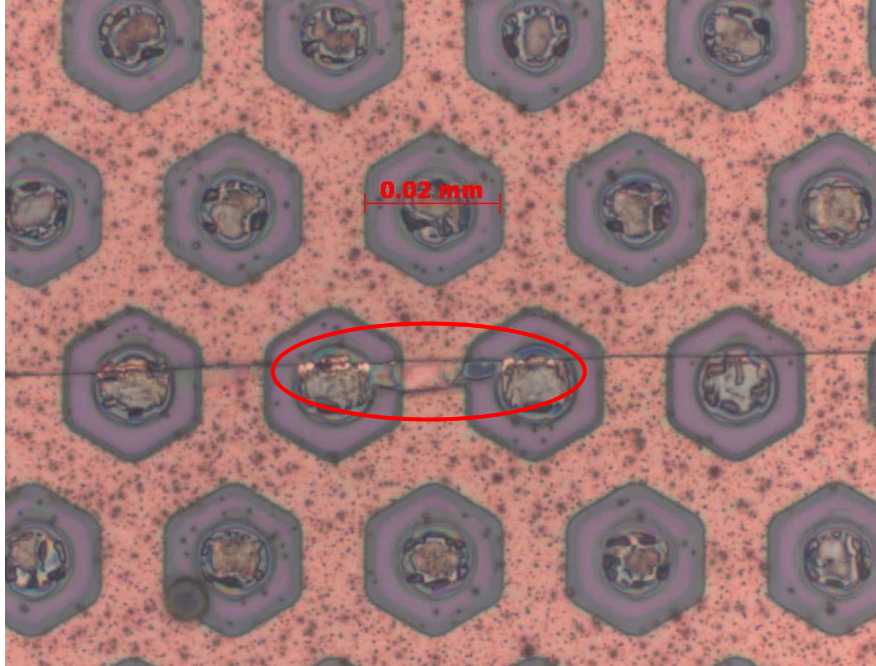
Top metal was removed in order to inspect the area of the liquid crystal transition site. A damaged gate region was observed along the crack (reference figures 13 and 14).

Figure 13: Photograph of the liquid crystal area showing a damaged gate region (circled).

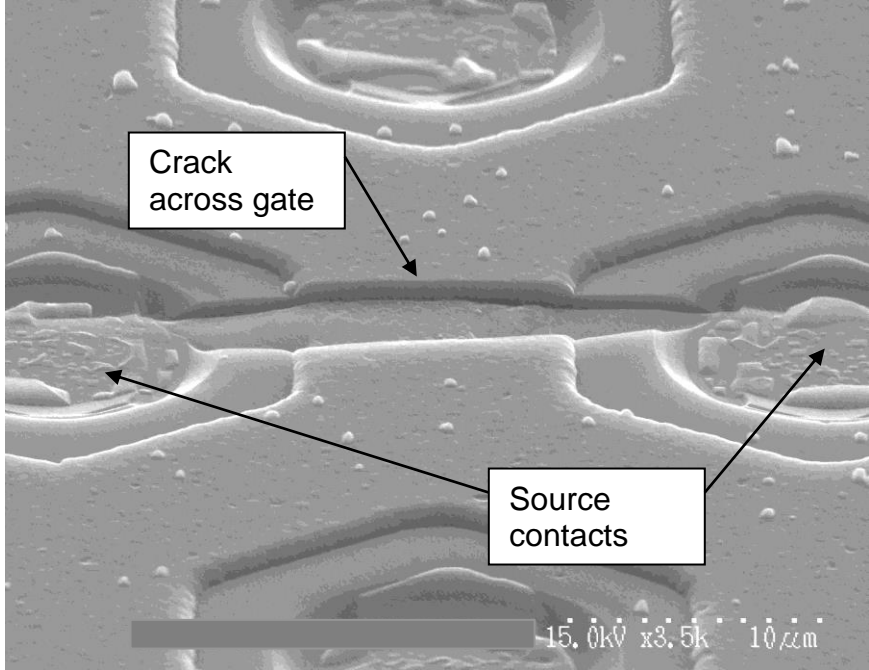
Figure 14: SEM image showing the damaged gate region.

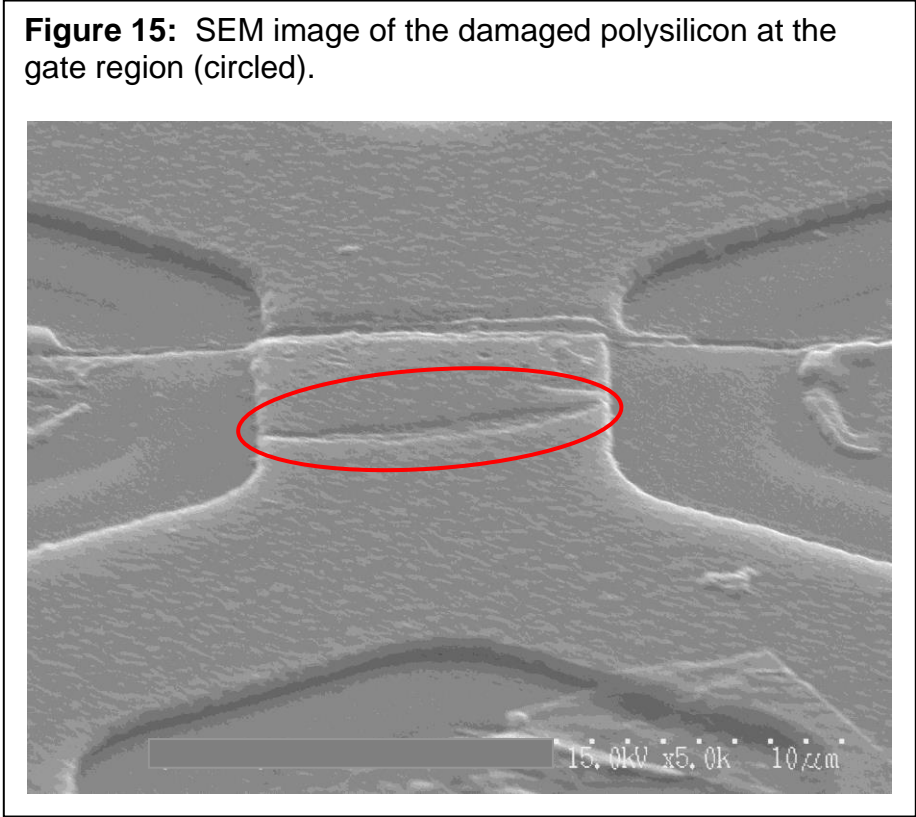
Further deprocessing was done to remove the oxide over the gate region. Figure 15 shows the damaged gate region.
